Rubblizing the Interstate System

Rubblizing. Ten years ago it was a strange word to many DOTs.

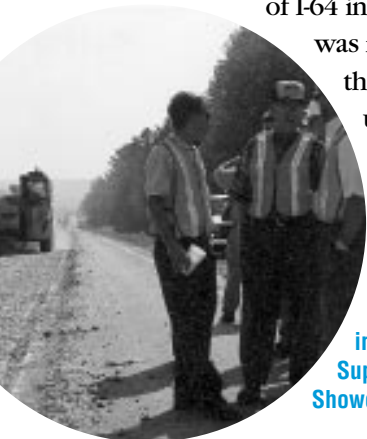
Rubblizing I-65 north of Birmingham during Alabama Superpave Showcase.

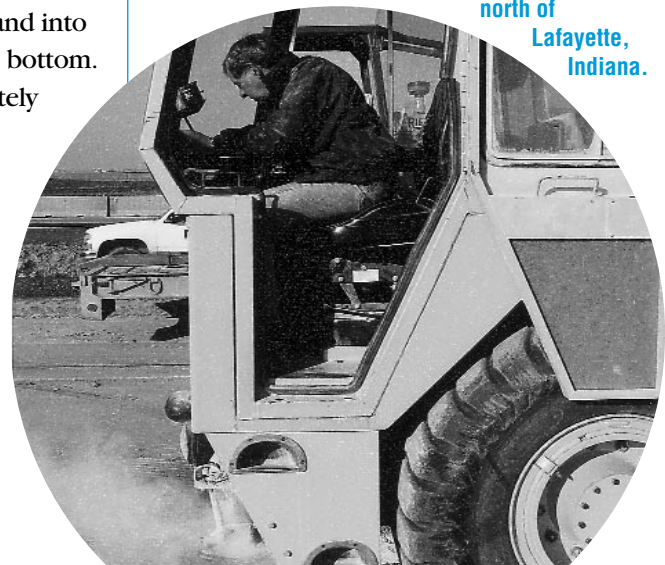
Rubblizing on I-65, north of Lafayette, Indiana.

Rubblizing on the I-65 job was accomplished with two low-

amplitude, high-frequency resonant breakers by RMI of Tulsa, Oklahoma. RMI has done more than 16 million square yards or nearly 80 percent of the rubblizing projects in the U.S. to date.

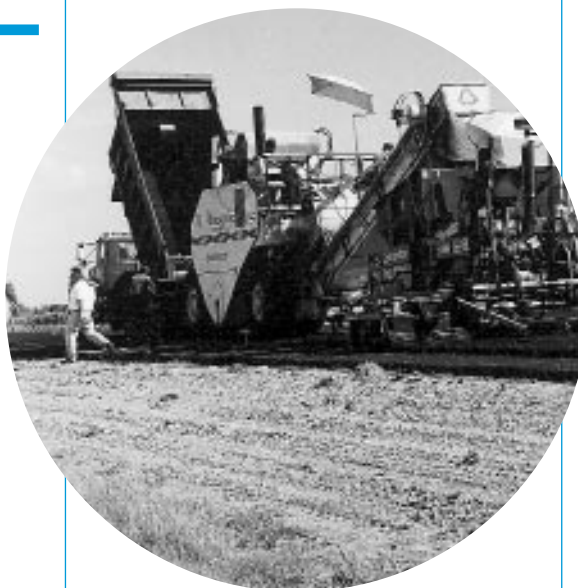
Overlaying the rubblized mainline on I-65 in Indiana with 13.5 inches of Superpave mix.

Indiana has been one of the most receptive states to covering rubblized concrete with Superpave overlays. On the I-65 rubblizing project, Indiana DOT placed more than 280,000 tons of Superpave HMA on the mainline and shoulders in 1998. Due to the increased permeability of some Superpave mixes, InDOT installed a drainage system on both sides of the rubblized pavement.

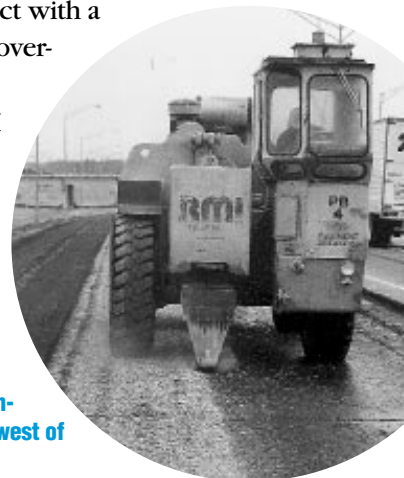
Rubblizing continuously reinforced concrete on I-20 west of Shreveport, Louisiana.

Two RMI rubblizing machines worked on the I-20

project, each working in separate half-mile areas. Multiple passes were made with the RMI 12-inch-wide resonant breaker. The two rubblizers traveled at approximately 8 mph and broke approximately 6,000 to 10,000 square yards of concrete per day, depending on the type of aggregate, concrete strength and pavement thickness.

The high-frequency, low-amplitude, rubblizers left relatively uniform rubble behind. The rubblized pavement was relatively level and contained a maximum particle size of approximately 3 inches.

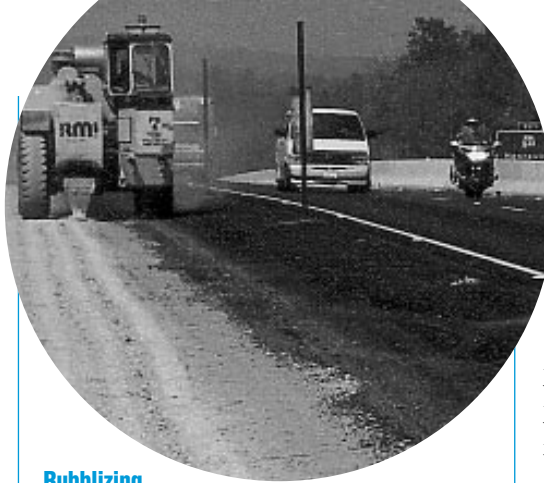
Rubblizing close to traffic on I-65 in Alabama.

A significant part of the rubblizing operation was done in lanes adjacent to heavy traffic and there was no problem operating the rubblizers in traffic lanes next to the lane with the new HMA overlay. Traffic control barrels were used to keep adjacent-lane traffic approximately 10 feet from the con-

struction operation. After rubblizing, the fractured surface was seated with a 10-ton twin vibratory steel drum roller.

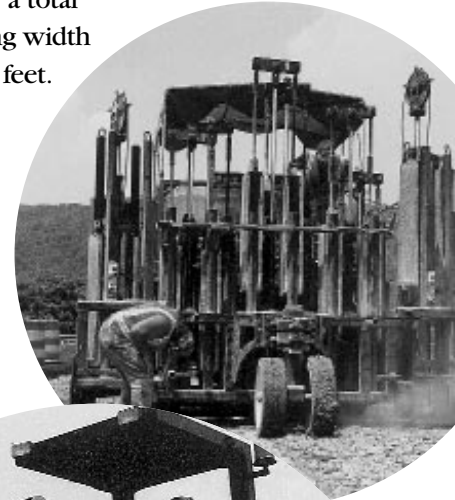
Rubblizing I-64/I-77, south of Beckley, West Virginia, with the Multiple-Head Breaker.

The MHB is a rubber-tired, self-propelled unit that carries twelve 1,000-pound hammers, 8 inches wide, mounted laterally in pairs. Each pair of hammers is attached to a hydraulic lift cylinder that operates an independent unit and cycles at the rate of up to 35 impacts per minute. The 8-foot-wide machine carries 12 hammers that are 8 inches in width. A 2.25-foot-wide carrying two 1,500 hammers, can be added to each side for a total breaking width of 12.5 feet.

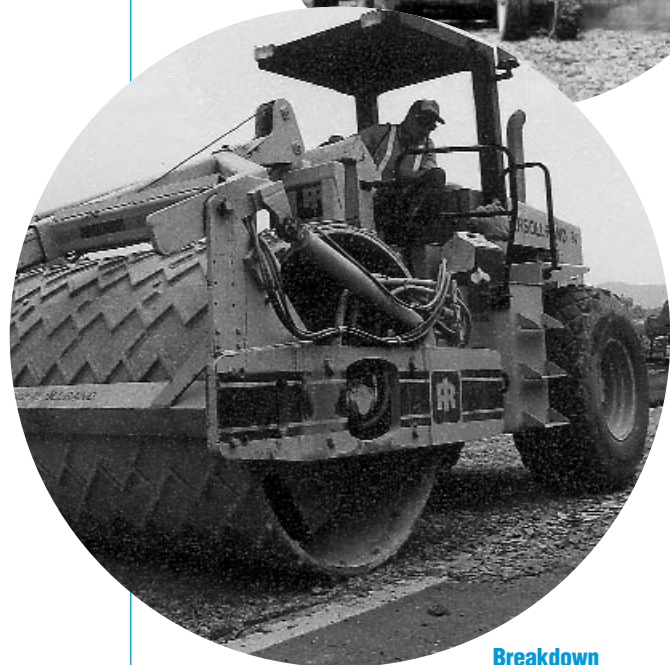
Breakdown compaction after rubblizing with the Multiple-Head Breaker was done with "Z" roller.

Compaction of the rubblized pcc was performed with a "Z" grade roller followed by a rubber-tired roller. A vibratory roller was used to finish the seating process.
