REPAIR

of Asphalt Parking Lots and Driveways

BY DWIGHT WALKER, P.E., EDITOR

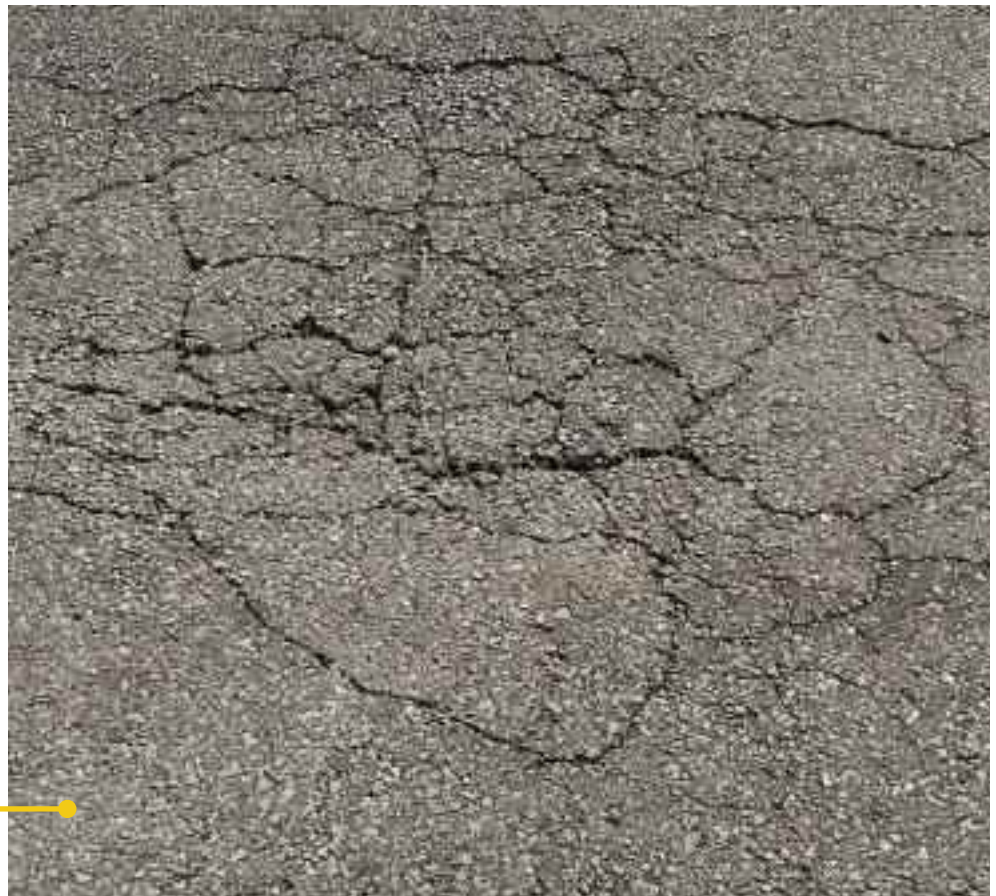
Alligator cracking is caused by weak spots in the subgrade, too little pavement thickness, excessive loading, or a combination of these problems.

Many commercial pavements suffer structural failures as a result of load-related deterioration. These problems usually show up initially as "alligator cracking," a form of fatigue cracking. These cracks appear on the surface of the pavement as a series of interconnected, small blocks resembling an alligator's skin. This cracking occurs under repeated traffic loading and is caused by weak spots in the subgrade, too little pavement thickness, excessive loading, or a combination of these contributors.

If alligator cracking is allowed to progress, it can become a full structural failure. Pieces break away and potholes form. Moisture enters the subbase and pavement support is lost. When this occurs a full-depth repair must be done.

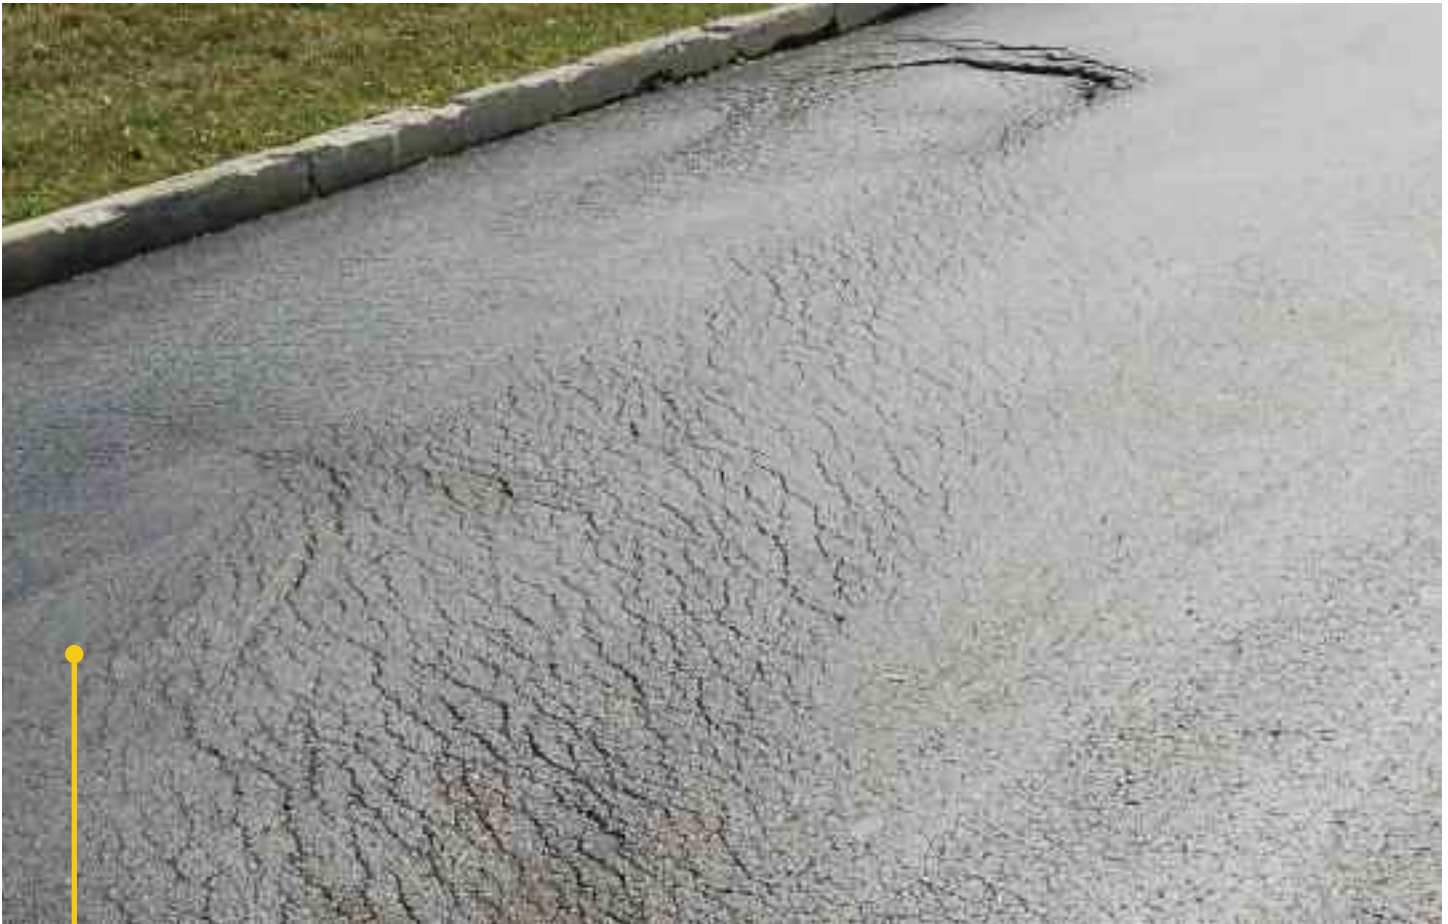
Slippage failures are caused by a lack of bonding between asphalt layers.

Slippage cracks are crescent-shaped cracks or tears in the surface layer(s) of asphalt where the new material has slipped over the

underlying course. This problem is caused by a lack of bonding between layers. The lack of bond may be because a tack coat was not used to develop a bond between the asphalt layers or because a prime coat was not used to bond the asphalt to the underlying stone base course. The lack of bond can be caused by dirt, oil, or other contaminants preventing adhesion between the layers. All of the area exhibiting the “stretch marks” will need to be removed. Make sure that the existing pavement is clean and dry after removing the failed layer. Then apply a tack coat to glue the old and new material together. Place and compact the new layer(s).
