# REPAIR

## *of Asphalt Parking Lots and Driveways*

BY DWIGHT WALKER, P.E., EDITOR

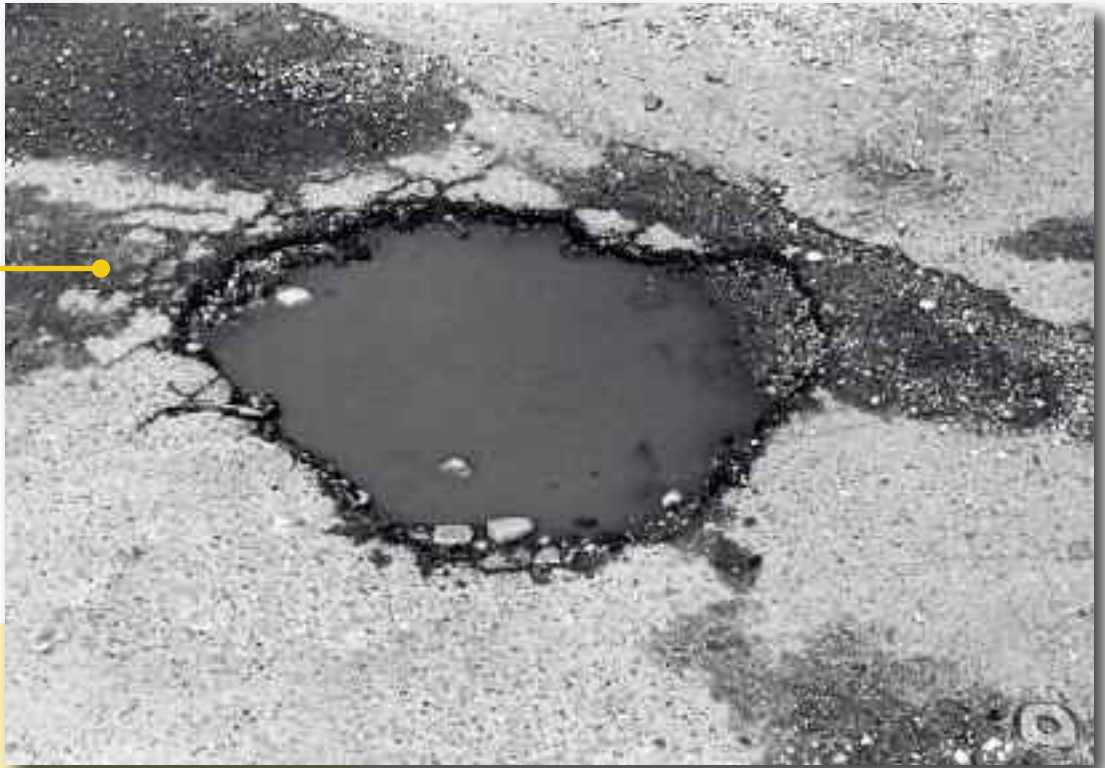
Potholes are typically caused by deterioration due to segregation, raveling, alligator cracking, or failures at joints and patches.

Potholes are bowl-shaped holes that result from the localized break-up of the pavement. They are typically caused by the continued deterioration of other type of distresses, such as segregation, raveling, alligator cracking, or failures at joints or patches.

Potholes should be permanently repaired by removing the failed material to the depth necessary to reach firm support, including removing part of the subgrade if necessary. Drainage may have to be installed if water in the pavement is contributing to the failure. The area to be removed should extend beyond the visibly damaged material to assure that solid material remains. To facilitate compaction of new material, the cut-out should be square-edged and rectangular-shaped.

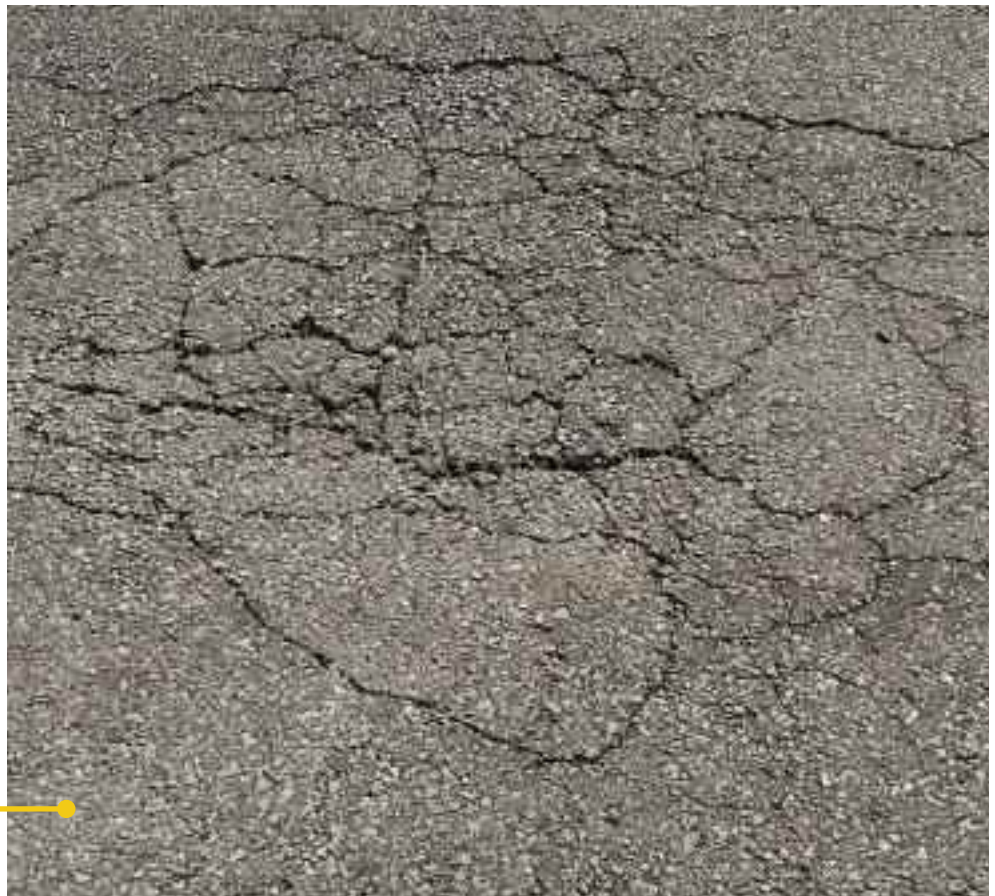
Many pavements fail because the asphalt is simply too thin to carry the loads.

Many commercial pavements fail because the pavement is simply too thin to carry the loads. Practically all parking lots are subjected to some truck traffic; delivery vehicles and garbage trucks are a fact-of-life. Building a pavement with sufficient thickness to handle these vehicles is a wise investment.

When a base failure occurs, the failed asphalt must be removed, the underlying material stabilized, and the pavement replaced. The cause of the failure must be identified and addressed. If the problem is a soft spot in the subgrade, this weakness must be fixed. If the problem was due to too little pavement thickness, the repair area will have to be undercut to allow room for additional thickness to be placed.

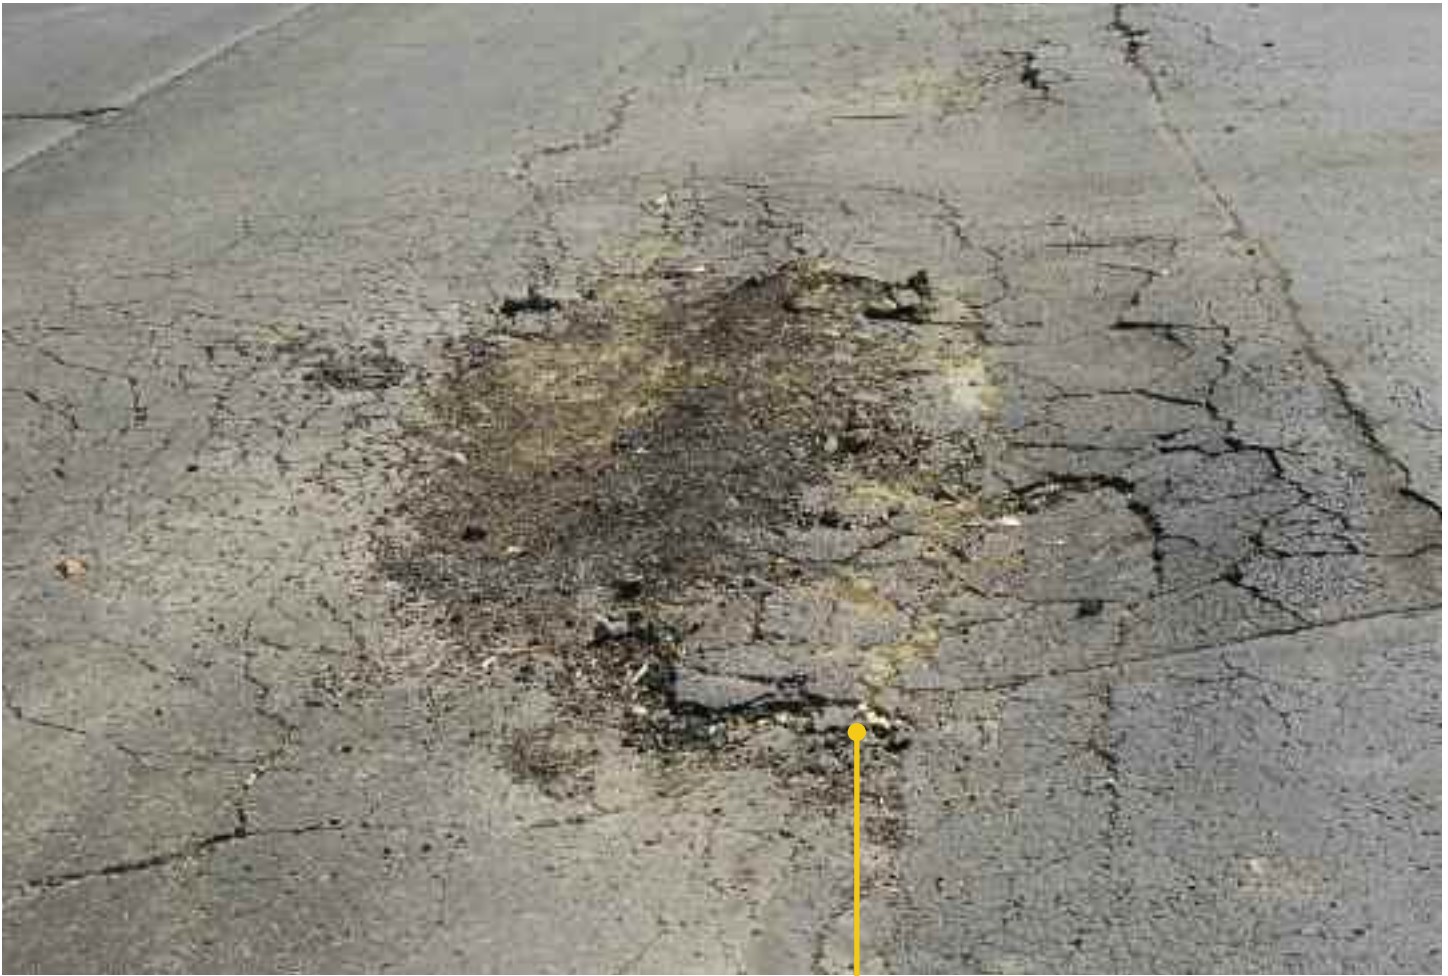
Alligator cracking is caused by weak spots in the subgrade, too little pavement thickness, excessive loading, or a combination of these problems.

Many commercial pavements suffer structural failures as a result of load-related deterioration. These problems usually show up initially as "alligator cracking," a form of fatigue cracking. These cracks appear on the surface of the pavement as a series of interconnected, small blocks resembling an alligator's skin. This cracking occurs under repeated traffic loading and is caused by weak spots in the subgrade, too little pavement thickness, excessive loading, or a combination of these contributors.

If alligator cracking is allowed to progress, it can become a full structural failure. Pieces break away and potholes form. Moisture enters the subbase and pavement support is lost. When this occurs a full-depth repair must be done.

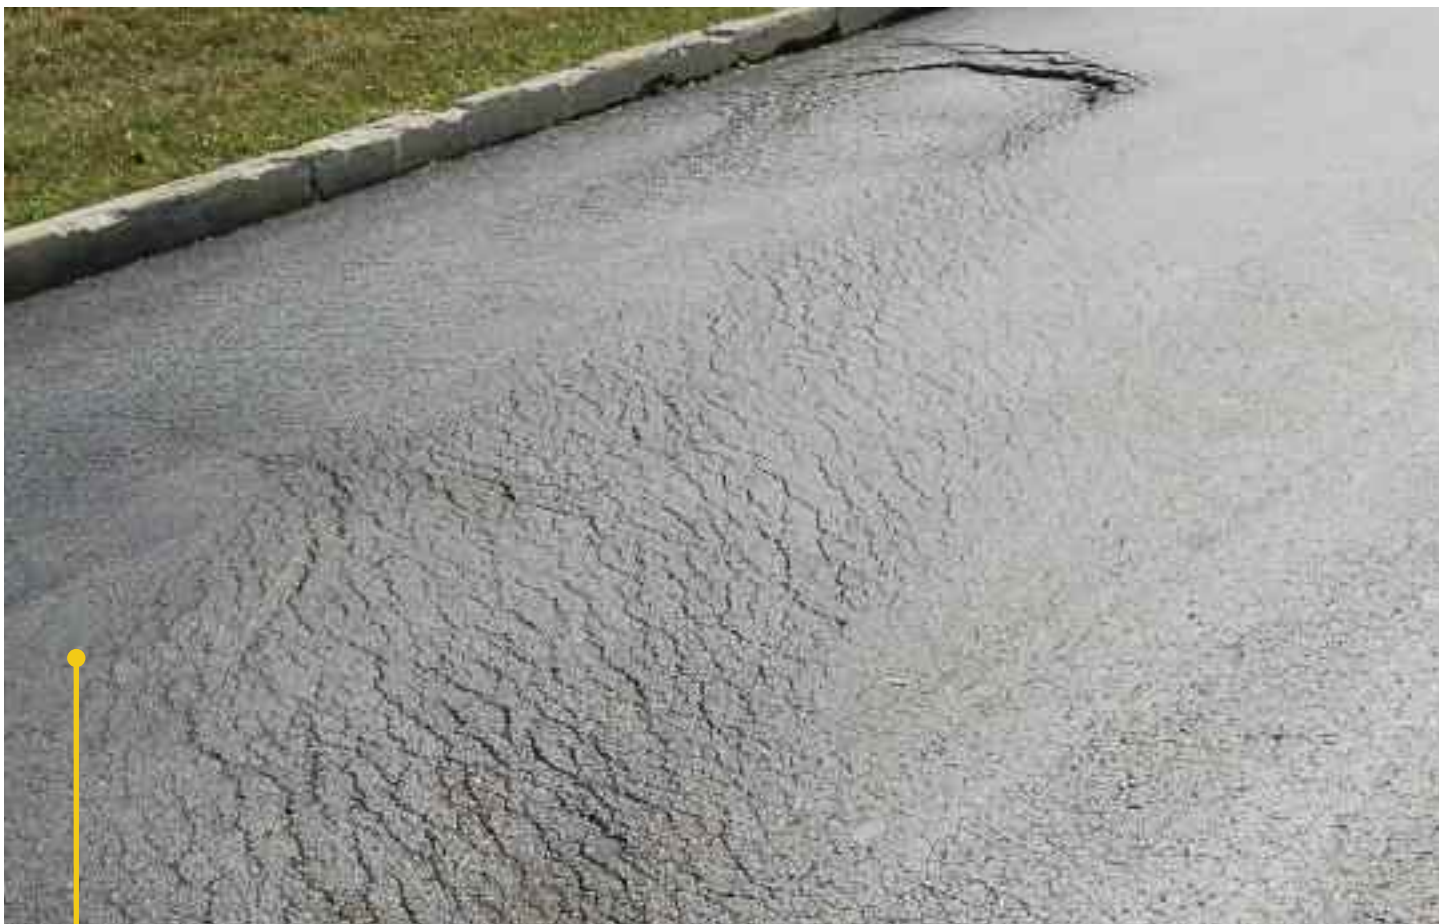
Slippage failures are caused by a lack of bonding between asphalt layers.

Slippage cracks are crescent-shaped cracks or tears in the surface layer(s) of asphalt where the new material has slipped over the

underlying course. This problem is caused by a lack of bonding between layers. The lack of bond may be because a tack coat was not used to develop a bond between the asphalt layers or because a prime coat was not used to bond the asphalt to the underlying stone base course. The lack of bond can be caused by dirt, oil, or other contaminants preventing adhesion between the layers. All of the area exhibiting the “stretch marks” will need to be removed. Make sure that the existing pavement is clean and dry after removing the failed layer. Then apply a tack coat to glue the old and new material together. Place and compact the new layer(s).
