Crumb Rubber Bituminous Mixes from Waste Tires in Argentina

By Marcela Balíge

This article is extracted from a study published for the Asphalt Rubber Congress held in Brasília, Brazil, December 2003, entitled "First Test Sections in Argentina Using Bituminous Mixes with Crumb Rubber Additive from Waste Tires."

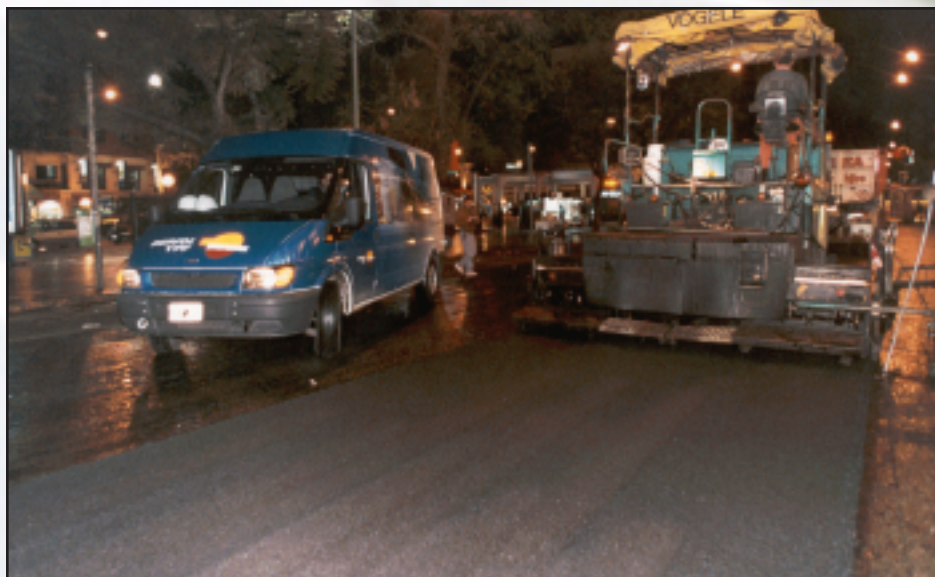
Placing the rubber modified asphalt.

The existing surface was a deteriorated asphalt layer which was milled before building the test section. Under this asphalt layer, the pavement structure consisted of a poor concrete over paving blocks on a sand bed. A conventional rapid-setting emulsion was used to tack the new rubberized HMA layer to the milled surface. The rubber-modified layer was placed at an average thickness of 4.5 cm.

The test section was constructed in September 2002. A batch plant was used to produce the mixes and the materials were placed between 9 p.m. and 12 a.m. Light rains complicated the compaction efforts, leading to the use of dynamic (vibratory) compaction.
